REPORT OF THE DIRECTOR
BUREAU OF SAFETY

ACCIDENT ON THE
ANN ARBOR RAILROAD

McBAIN, MICH.

INVESTIGATION NO. 2350

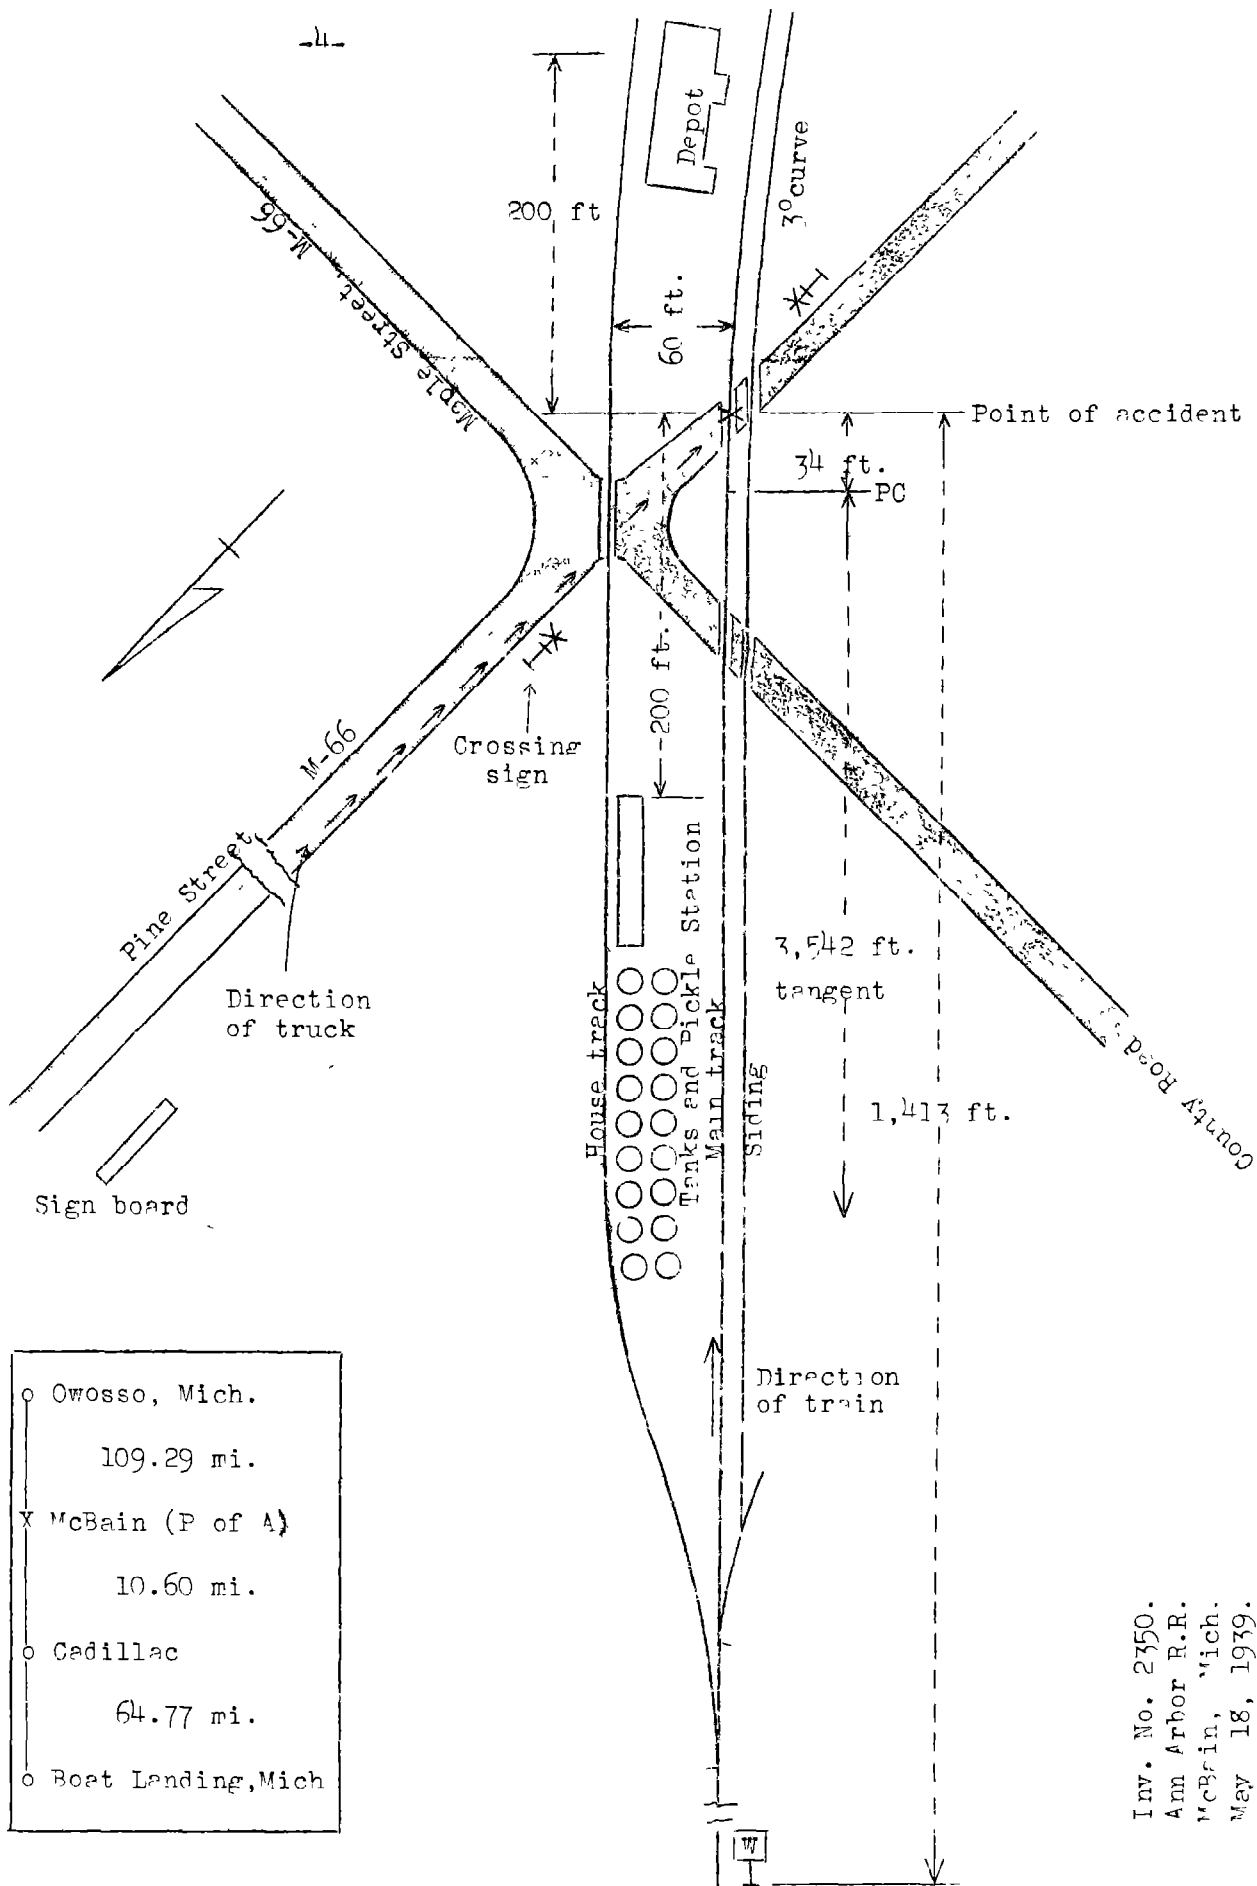
Inv. No. 2350.
 Ann Arbor R.R.
 McBain, Mich.
 May 18, 1939.

The crossing involved is protected by two cross-buck signs, which are furnished by the State Highway Department and bear the words "RAILROAD CROSSING 3 TRACKS" in reflector buttons. One sign is located 25 feet west of the center-line of Pine Street and 168 feet north of the center-line of the main track, or 70 feet north of the center-line of the house

track; the other sign is located south of the siding and east of the street. The tops of these signs are about 11 feet above street level.

At a point 300 feet north of the main track, the driver of a south-bound vehicle could have an unobstructed view of an approaching east-bound train a distance of 950 feet. Between 300 and 210 feet the view is obstructed by a sign-board 15 feet high by 51 feet wide, located 57 feet west of the center-line of the street. From 210 to 100 feet the view is unobstructed a distance of 1,250 to 1,390 feet. A pickle-station building, 30 feet wide, 75 feet long, and 18.5 feet high, located 200 feet west of the crossing and 29 feet north of the main track, obstructs the view from 100 feet to 49 feet north of the main-track crossing. At 49 feet the view is unobstructed a distance of 750 feet; at 33 feet the view is unobstructed a distance of 3,600 feet; between 33 and 25 feet a pole line obscures the view, and from 25 feet to the main track the view is unobstructed a distance of 3,600 feet.

Approaching the crossing from the north the driver's view of an approaching east-bound train was unobstructed for various distances as progress toward the crossing was made. Throughout a distance of 25 feet immediately north of the crossing the view was unobstructed a distance of 3,600 feet.
