INTERSTATE COMMERCE COMMISSION

REPORT OF THE CHIEF OF THE BUREAU OF SAFETY COVERING
THE INVESTIGATION OF AN ACCIDENT WHICH OCCURRED ON
THE NEW YORK CENTRAL RAILROAD NEAR WATERLOO IND,
MARCH 21, 1917

DECEMBER 23 1918

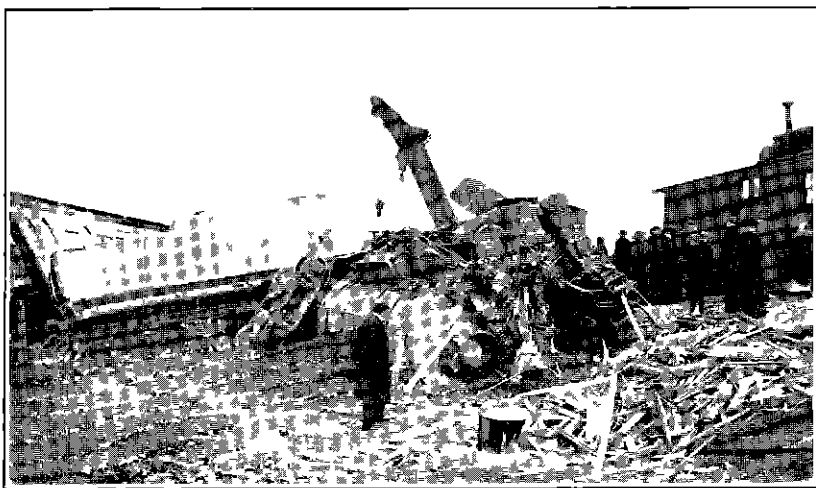
FIG. 1—End of tail of passenger train. View looking east.

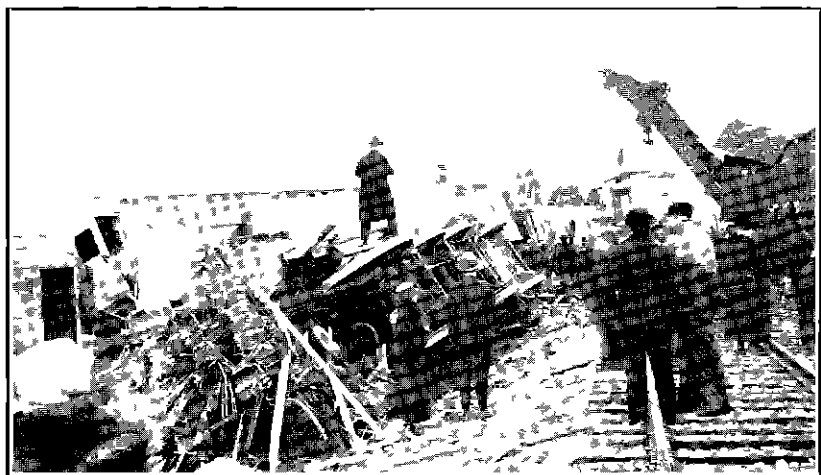
FIG. 2—Underside of engine of passenger train. Fourth car of freight train refrigerator car No. 41897, over on westbound track.

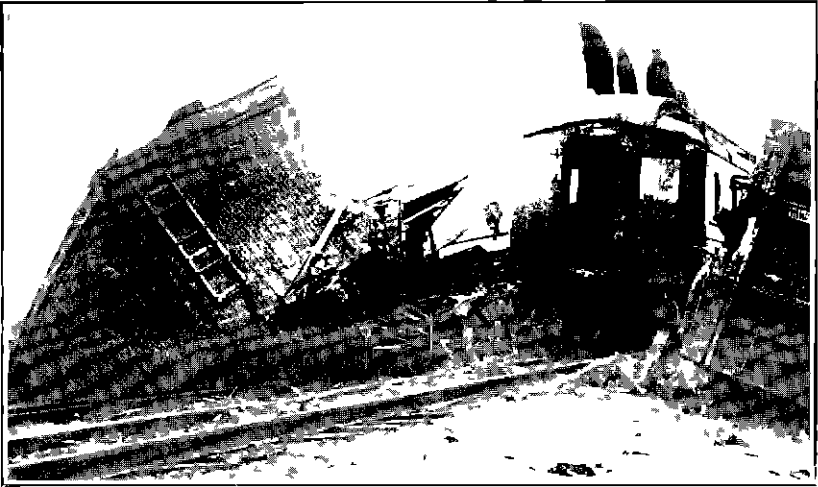
FIG. 3—Third car of freight train No. 11867 and No. 26223, after collision with passenger train No. 100.

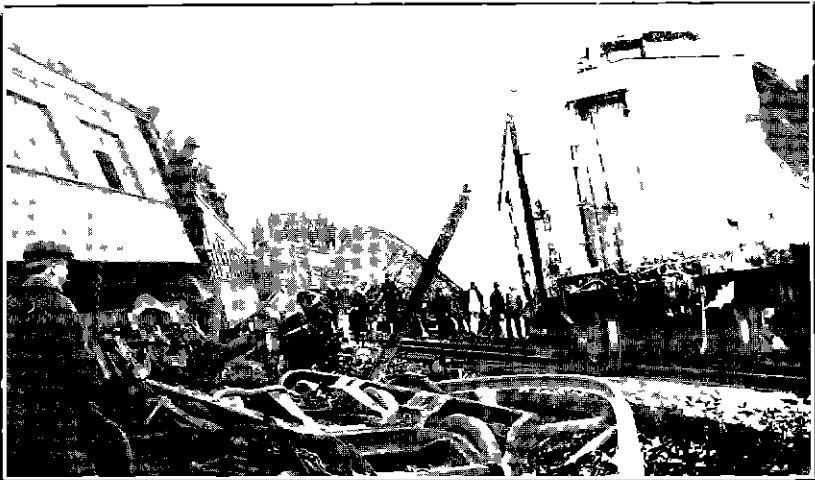
FIG. 4—Fourth car of freight train No. 11867, in the wreckage of stock car No. 26223, after collision with passenger train No. 100.

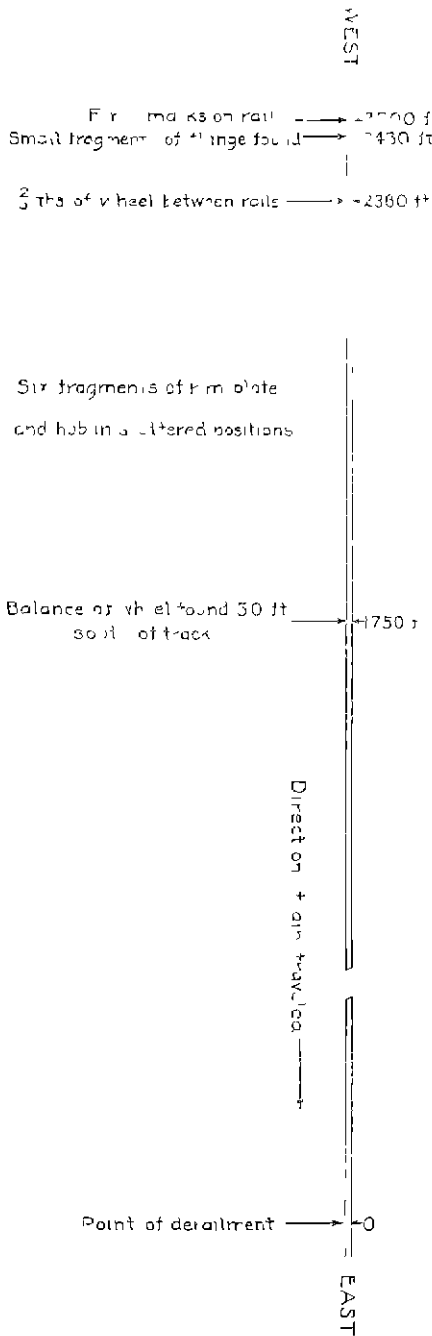
Diagram of the track, figure No. 5, shows the relative positions which the fragments occupied after the accident. The first marks found were on the south end 2500 feet west of the point of derailment. Immediately beyond these marks a small fragment of the flange was found. Next in order a large fragment comprising about two-fifths of the wheel was found between the rails about 120 feet east of the first marks.

Next beyond this point six fragments of the rim, plates and hub were scattered along the track. Finally, at a distance of 1700 feet west of the point of derailment the balance of the wheel was detached from the axle and came to rest 50 feet from the track on the south side. The track was examined for a distance of 2 miles west of the scene of the accident but no further evidence was found attaching to it. Parts of the flange were not recovered.

The relative positions occupied by the fragments furnish evidence upon the manner of failure and the sequence in which the lines of rupture were developed. Fragmentation seemed to have begun at the rim, the earliest recovered fragment being a small piece of the flange. A large fragment was next detached representing about two-fifths of the body of the wheel. The balance of the wheel remained on the axle for a short time thereafter since at this stage more than one-half of the hub covering the wheel seat was unbroken.

Fig 5.—Diagram showing the relative positions of the fragments of broken wheel No. 91051, as they were found after the accident

A sector representing one-twelfth of the body of the wheel was broken into small fragments the pieces of which were next scattered along the track. More of the hub was then broken releasing the balance of the wheel from the axle. This fragment, the largest of the wheel, came to rest on the south side of the track 50 feet away and 1750 feet west of the point of derailment as above stated.

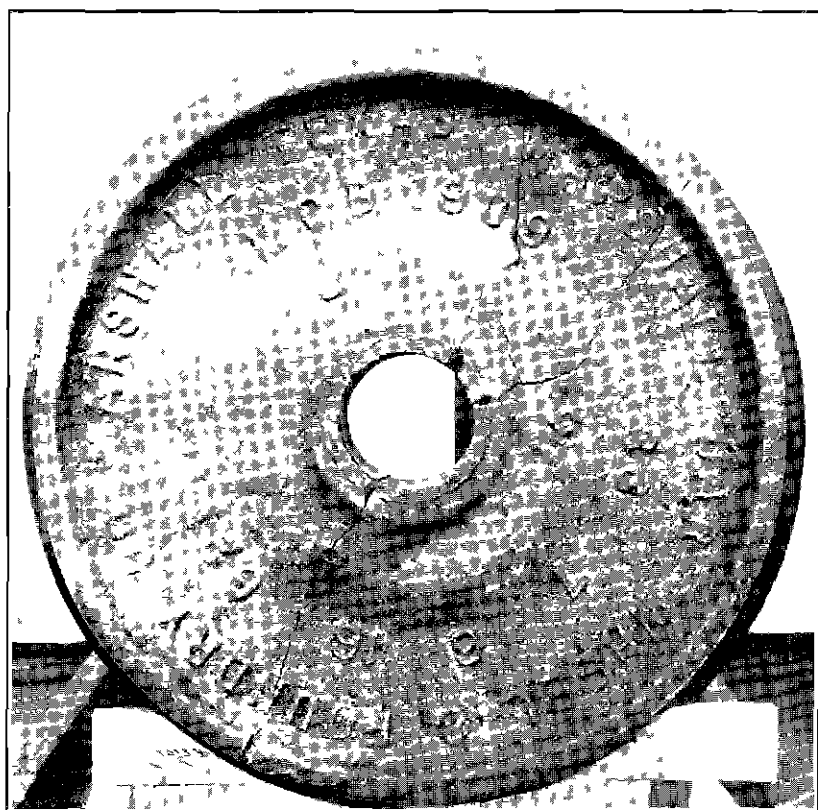
The lines of rupture on the outer and the inner faces of the wheel are shown by figures Nos. 6 and 7. The wheel broke into two principal fragments, between which there was a sector which was broken into a number of small pieces. Figure No. 8 shows the local shattering of the rim at the circumference of the small sector. Parts of the flange were not recovered. It is regarded as probable that the initial rupture of the wheel occurred within the limits of this shattered zone of the tread and flange. Fracture of the wheel from the hub, or core leg opening extending outward would not be expected to result in such a degree of fragmentation as here witnessed. The strength of the rim would call for an intact plate at the time of being broken into a number of small fragments to furnish the necessary reactive force.

FIG. 6. Pioner wheel No. 949, outside face. Shown, faded lines of rupture, detaching "two main fragments" with section of "full thickness".

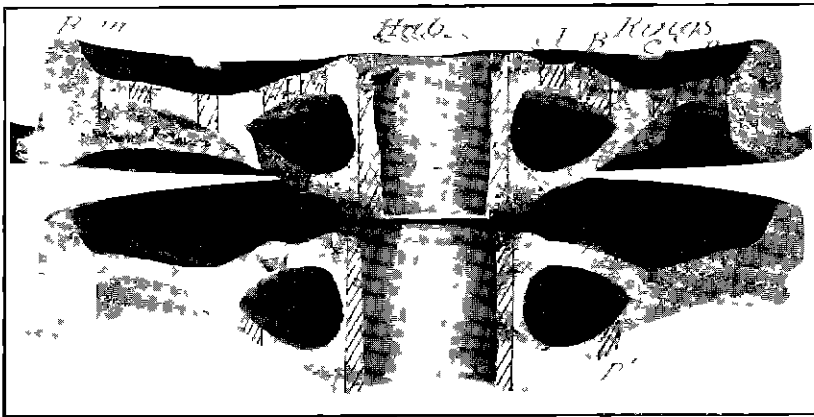
FIG. 10.—Fracture lines of rim, plate, and hub of broken wheel No. 940. Lines of rupture passed through core legs and exterior of plates. Spongy metal at outside end of hub. Loss of ribs sketched on cut, which were detached from mate of the wheel.

Figure No 10 shows the appearance of the fractured surfaces of the rim plates and hub. A normal depth of chill was presented with a progressive gradation from the white iron of the tread through mottled iron to gray in the plates and hub. The metal at the outer end of the hub in both this wheel and its mate was spongy. In other places the metal was sound. In the examination of the mate of the broken wheel concentric rings were taken out in the determinations of the state of internal strains. The positions of these rings are for convenience sketched on this cut.

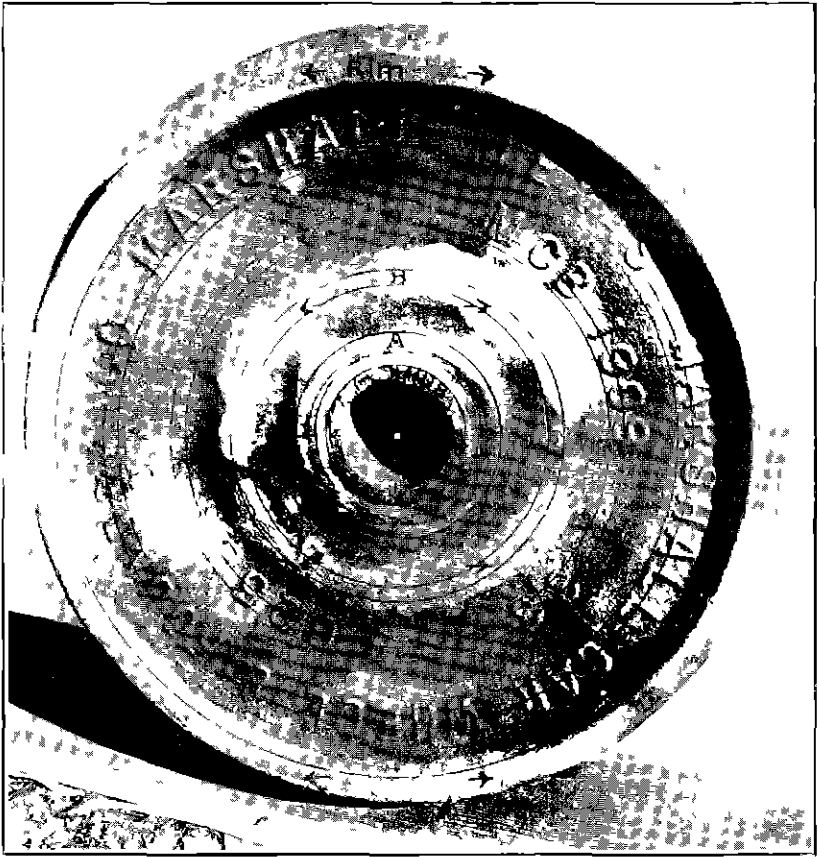
FIG. 11.—Cut used to represent wheel N in figure of the broken wheel, showing positions of concentric rings detached therefrom. The center of wheel is C . Outside face of wheel

The measured strains and their equivalent stresses which were released on the outside face of the hub, plate, and rim of figure No. 11 are entered on Table No. 2.

It will be noted that the internal stresses of compression at the hub were 20,040 and 13,560 pounds per square inch on gauged lengths *a* and *b* respectively yielding an average value of 16,800 pounds per square inch. In the ring next the hub the compressive stresses had an average value of 4,590 pounds per square inch. In order to balance these compressive stresses at the hub both inside and outside plates were in a state of initial tension. At the rim there was a compressive stress of 4,420 pounds per square inch at one chord, while at the other chord the stress was negligible in value.

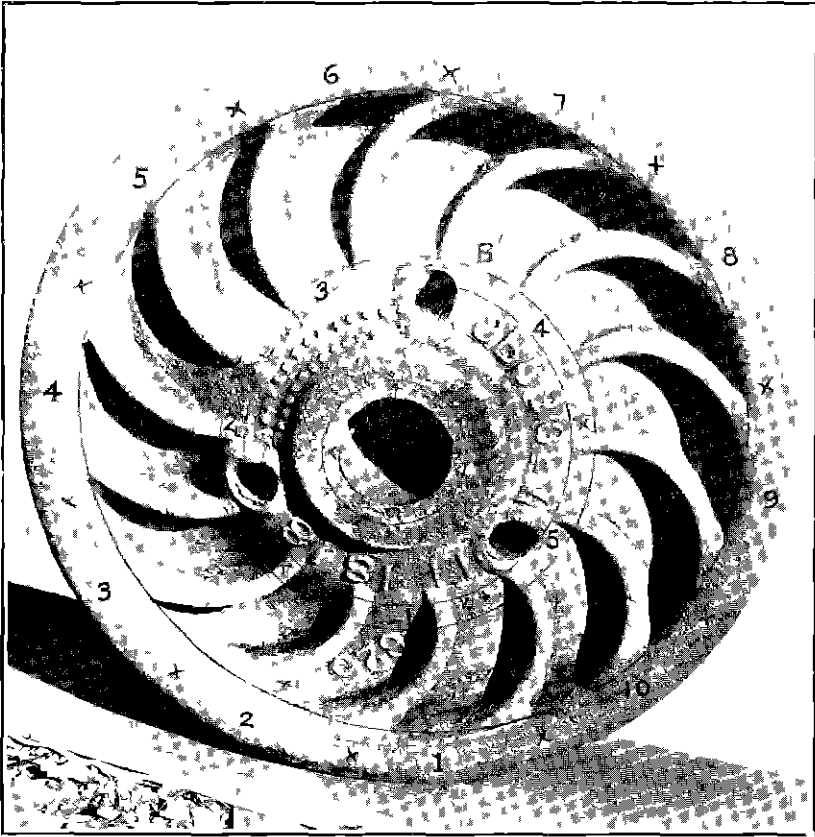
FIG. 12.—Cut used to represent wheel No. 9006, with of the broken wheel—showing positions of certain rims detached therefrom with locations of caused fault.—Inside face of wheel.

The strains and stresses of the inside face of the wheel are given on Table No. 3 referring to the gauged lengths which are shown on figure No. 12.

At the hub the compressive stresses were 23,910 and 27,030 pounds per square inch, respectively, on diameters at right angles to each other. The average of these two values is 25,470 pounds per square inch. On ring B's chord gauged lengths were established. Each

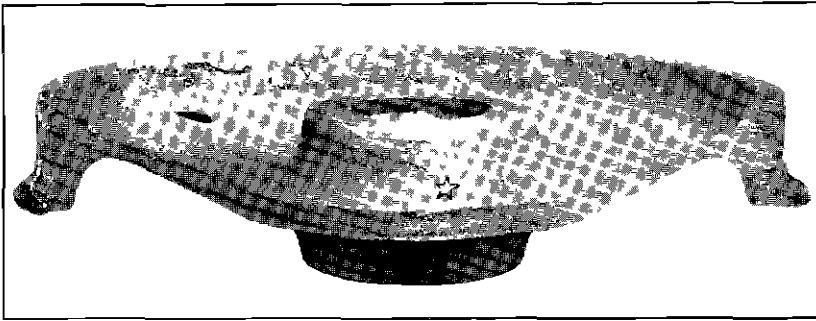
FIG. 14.—Fractured forged steel wheel. Incipient point of rupture on the outside of the plate in the hub indicated by a star sketched on the cut.

Forged steel wheels have exhibited fractures attributable to repeated flange blows. Figure No. 14 illustrates such a fracture in a forged steel wheel. The initial point of rupture is indicated by a star sketched on the cut. From this point the line of rupture extended in each direction until the fracture of the plate and rim was complete. A hot rim and cool plate intensify the radial strains of tension in the latter while the internal strains of compression acquired at the tread due to the cold-rolling action of a forged steel wheel would still further increase the strains in the plate. The rigidity of the metal of the tread of a chilled iron wheel probably preserves it against change of internal strains augmenting those of the plates by service conditions. Upon this feature, however we are without experimental evidence.
