INTERSTATE COMMERCE COMMISSION

REPORT OF THE DIRECTOR OF THE BUREAU OF SAFETY IN RE
INVESTIGATION OF AN ACCIDENT WHICH OCCURRED ON THE
PERE MARQUETTE RAILWAY AT MCGREW JUNCTION, MICHIGAN,
ON JULY 25, 1930.

September 11, 1930.

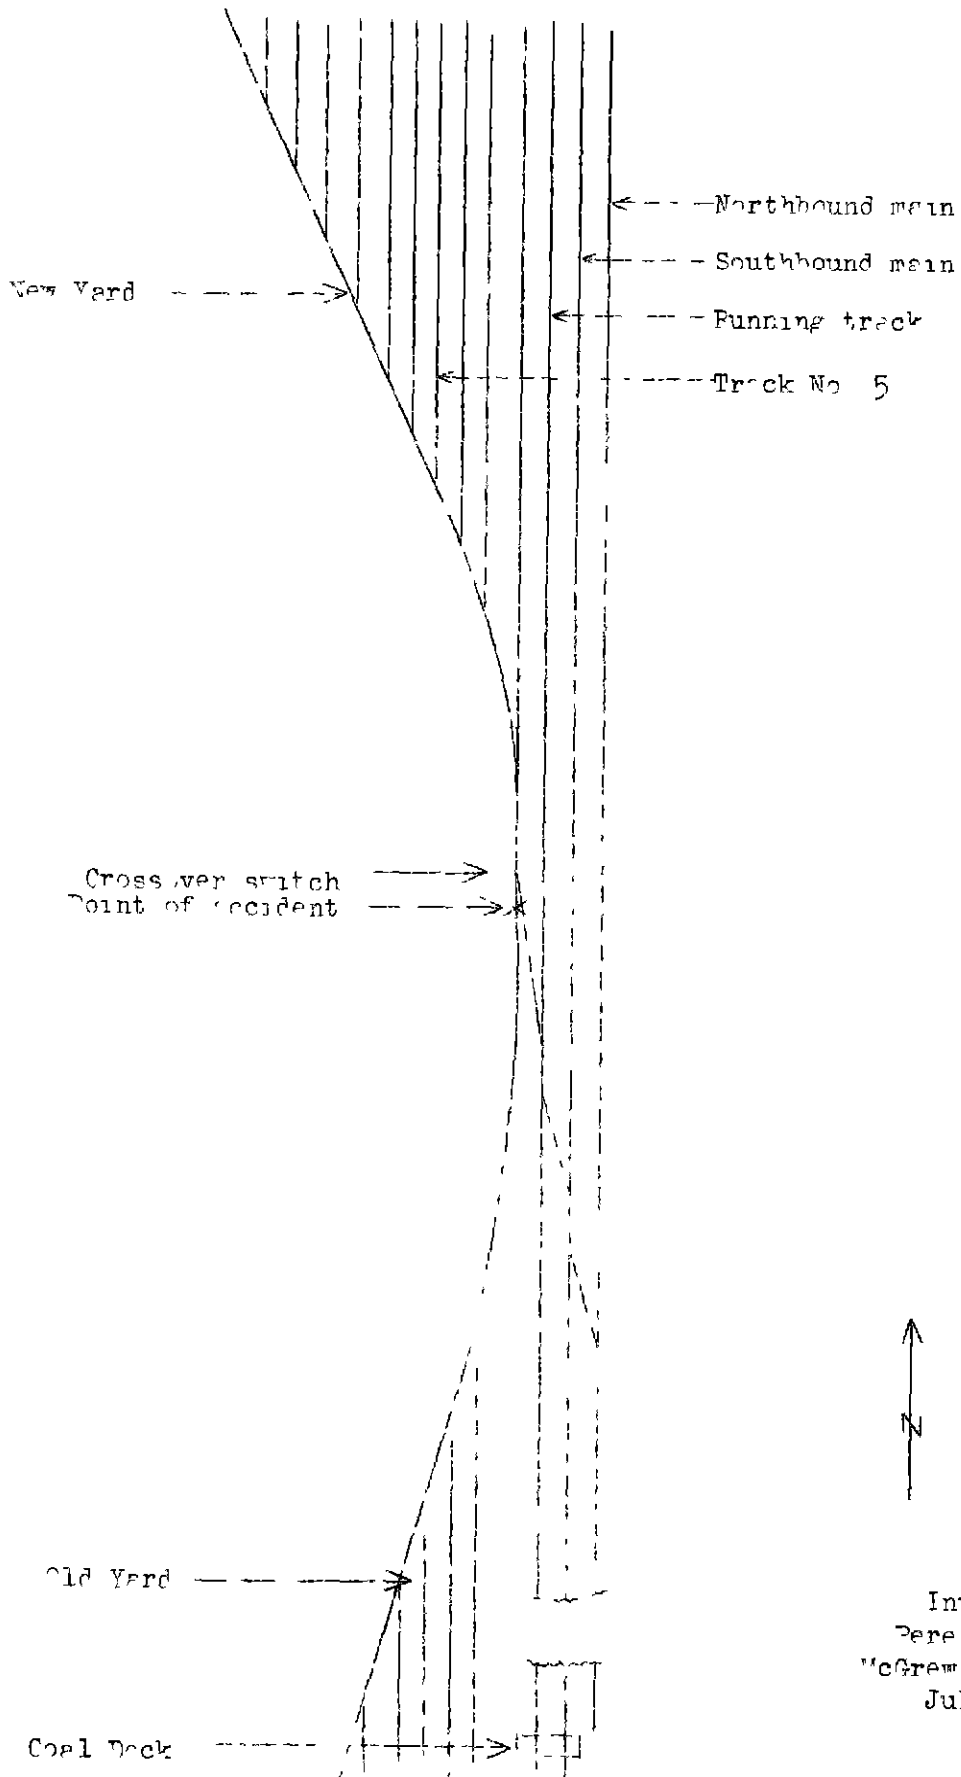
Inv. No. 1655
Pere Marquette Ry
McGrew Junction, Mich
July 25, 1930

The tender of engine 143 struck the tender of engine 1320 about 7 feet from the rear on its right side; evidently engine 143 had stopped at this point and engine 1320 continued to back up, raking the side of the tender and resulting in right side of the cab being crushed against the boiler head. Neither engine was derailed. The employee killed was the engineman of engine 1320.
