INVESTIGATION NO. 3232

CHICAGO AND NORTH WESTERN RAILWAY COMPANY

REPORT IN RE ACCIDENT

AT ROCK, MICH., ON

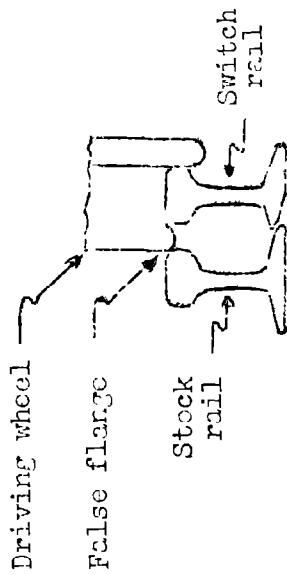
Cross section of switch rail and stock rail  
12 feet from point-of-switch

Examination after the accident disclosed that the first mark on the track structure in the vicinity of the east siding-switch was a scratch mark extending across the top of the frog of the turnout at a point 3-1/2 inches outside the gage side of the south main track rail. The next mark eastward was on the gage side of the south stock rail at a point 12 feet west of the switch points. At that point the distance between the gage sides of the switch-rail and the corresponding stock rail was 4 inches. Throughout a distance of 20 feet east of this point there was a pronounced scoring on the gage side of the stock rail at its upper edge. The inside of the base of the stock rail was raised about 1/2 inch at the switch points. The stock rail was canted outward and there was a gap of about 1 inch between the stock rail and the switch point. Beginning about 8 feet east of the switch points the gage side of the south rail was heavily scored, and it was canted outward throughout a distance of 157 feet eastward. Between points 38.7 feet and 162.7 feet east of the switch points the inside joint bars and bolts of the south rail were heavily damaged and some were broken. Between points 162.7 feet and 717.7 feet east of the switch the south rail was overturned southward. Between points 240 and 714 feet east of the switch the north rail was overturned northward.
