INTERSTATE COMMERCE COMMISSION

REPORT OF THE DIRECTOR

ACCIDENT ON THE
GRAND TRUNK WESTERN RAILROAD

JUNE 9, 1937

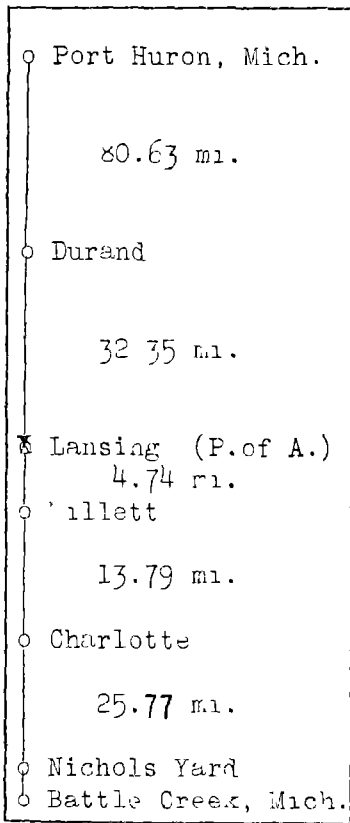
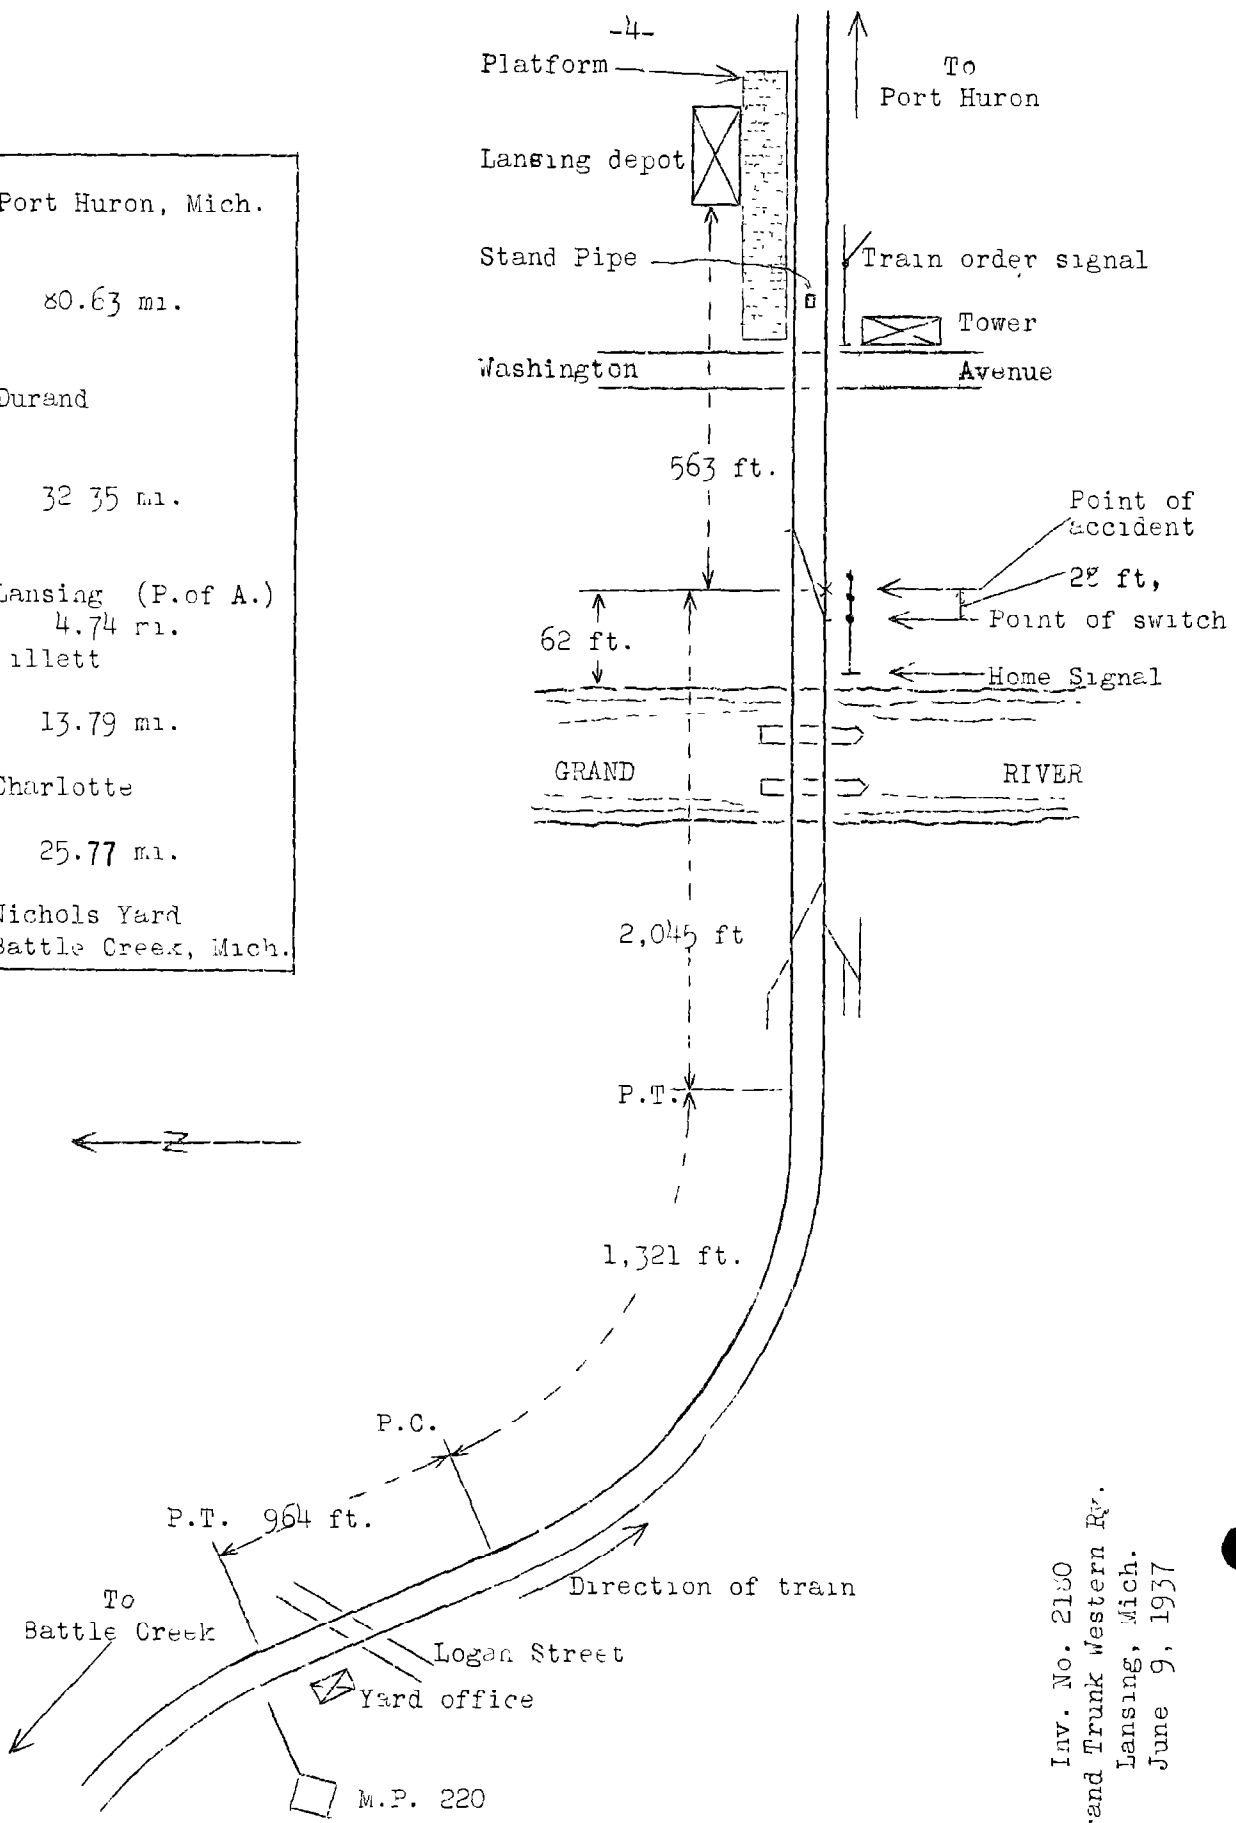
Inv. No. 2150
 Grand Trunk Western Ry.
 Lansing, Mich.
 June 9, 1937

Engine 6301, its tender and the first 27 cars in the train remained on the track as did the 8 rear cars and caboose; the rear truck of the 28th car was derailed, but it remained coupled to the forward portion of the train, and stopped 1,050 feet east of the totally derailed cars. The twenty-ninth to fortieth cars, inclusive, were derailed and stopped in various positions on and across both main tracks and the cross-over, all within a distance of 450 feet; the body of the twenty-ninth car, S.F.R.D. 14559, was torn from its trucks and lay on its side across the westward main track and the station platform. During the course of derailment the signal tower located about 6 feet south of the tracks and about 10 feet east of the sidewalk of Washington Avenue was struck and practically demolished. The eastward main track was considerably damaged for a distance of 340 feet. The employee injured was the operator in the tower.
