REPORT OF THE DIRECTOR
BUREAU OF SAFETY

ACCIDENT ON THE
PERE MARQUETTE RAILWAY

BEECH, MICH.

INVESTIGATION NO. 2236

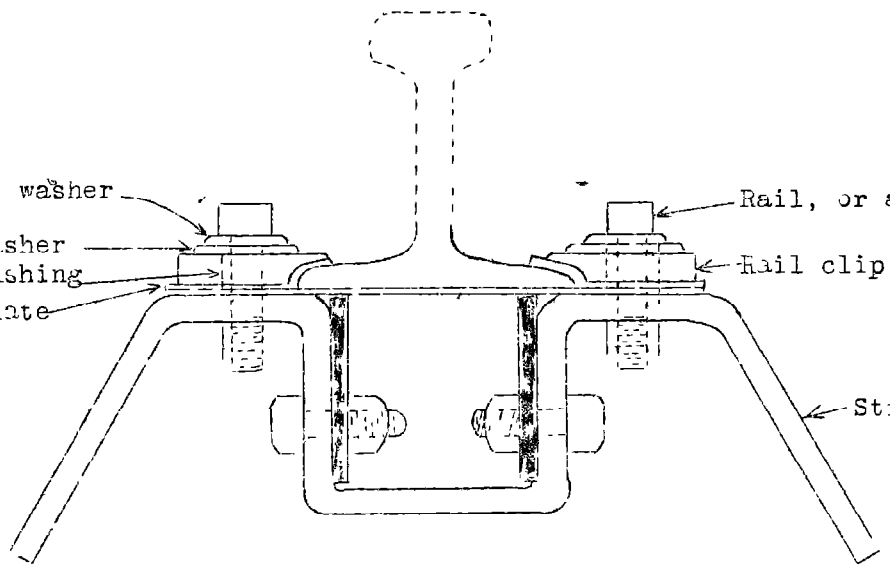
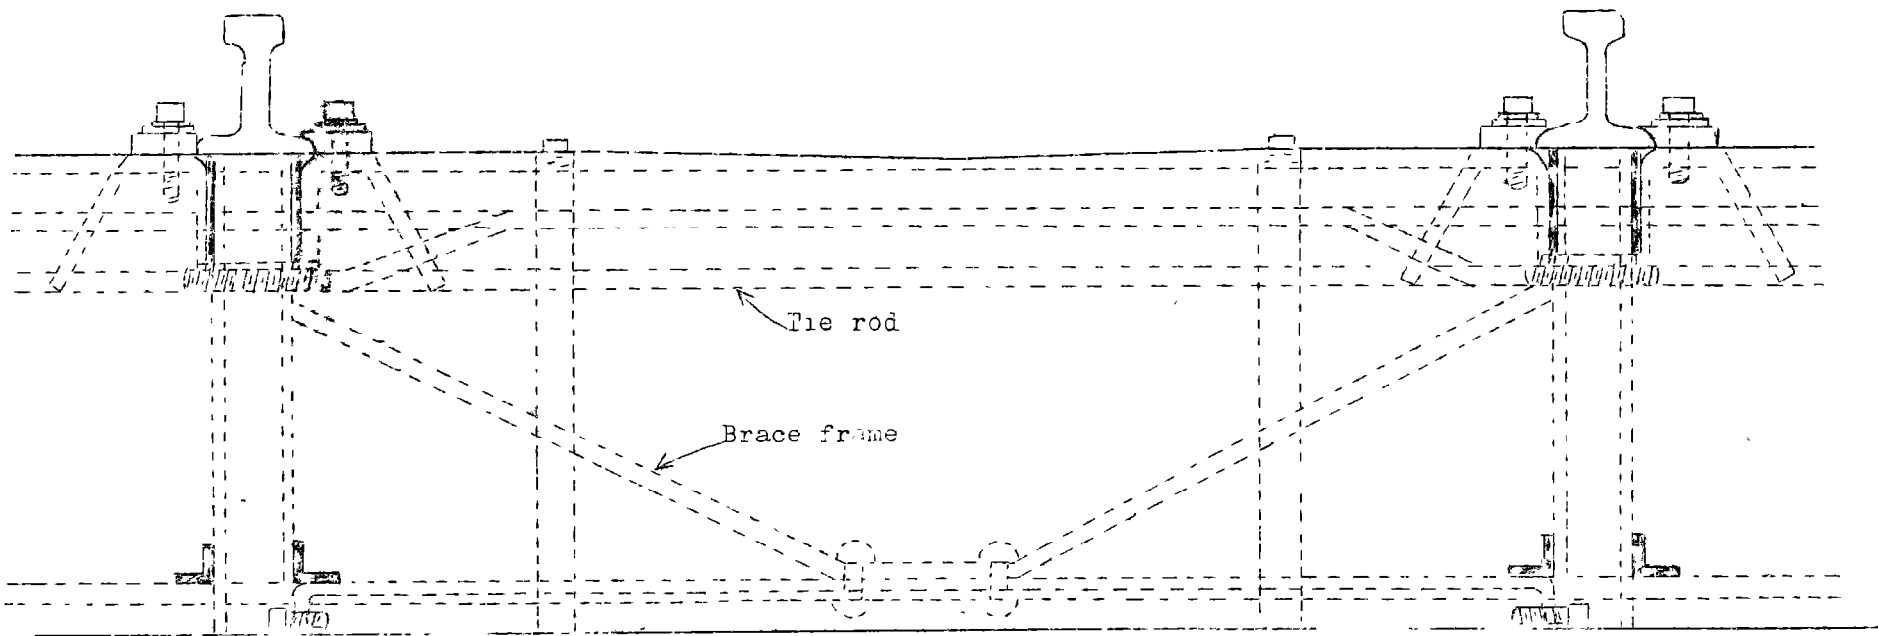
Detail of rail fastenings

Track Supervisor Meier stated that the principal trouble experienced with the track on the old section of concrete roadbed was due to breakage of the track anchor bolts at or beneath

the surface of the concrete. This trouble started as soon as the section of track was placed in operation. There has been no trouble due to heaving of the roadbed but occasionally a variation of cross-levels, not exceeding 1/16-inch, develops due to wear of the insulating material under the rail or the swelling of this material due to saturation. A rigid inspection is maintained, the section foreman having instructions to patrol the section daily. It was his opinion that the derailment was due to failure of the rail fastenings which permitted the rail to move out sufficiently for the wheels to drop inside of the rails. He was unable to state definitely how many anchor bolts were broken monthly but estimated the number at from 8 to 15. He thought, too, that the accumulation of snow and ice on the inside of the rails might have tended to move the rails out of place. After the accident he found that all of the fastenings on the north side of the north rail westward from the point of derailment were broken or out of place.

first winter of operation numerous failures in the operation of the block signals required replacement of the Fiberock with standard insulation fibre. This fibre is 1/8 inch thick and has proved satisfactory for insulating purposes. The rail clips and anchor bolts are insulated with the same material. He was of the opinion that the wide gauge east of the point of derailment developed under train No. 103 or the train immediately preceding it, and thought that a factor of considerable importance among the possible causes of derailment was the icy condition caused by the rain and sleet storm of December 14th. While it was evident that spreading of the rails was the immediate cause of derailment, the manner in which the north rail was bent around the last bolt that remained in place indicates that some abnormal stress was applied, but just what this stress might have been he was unable to state. However, inasmuch as the inspection and maintenance at the present time is the same as that which has been practiced for the last 11 years without derailment occurring, he concluded that this accident was occasioned by the application of some unknown powerful force, as above suggested, or by swelling of the insulating materials due to having become saturated and then frozen. The resultant swelling raised the rail clips, permitting the rail to move outward and establish a track gauge 1 inch wide. He stated that during the year 1937 up to the date of derailment 410 anchor bolts were replaced on the concrete roadbed; the number replaced monthly ranged from zero in September to 150 in February. Most of these bolts were damaged during the renewal of insulation. After the derailment the track for over 500 feet east of the point of derailment was gauged and the gauge ranged from 4 feet 9 inches to 4 feet 10 $\frac{1}{2}$ inches; on the same stretch the track levels varied from 1/8 inch high to 3/8 inch low. West of the point of derailment 261 rail fastenings were broken off on the north side of the north rail and 9 on the south side.

The track was covered with about 2 inches of ice. The rail clips and the anchor bolts had been cut off along the north rail and that rail, for a distance of 1,031 feet west of the point of

This derailment was caused by spreading of the track, apparently due to failure of rail fastenings used on track of special construction.
