REPORT OF THE DIRECTOR
BUREAU OF SAFETY

ACCIDENT ON THE
PERE MARQUETTE RAILWAY

BEECH, MICH.

INVESTIGATION NO. 2236

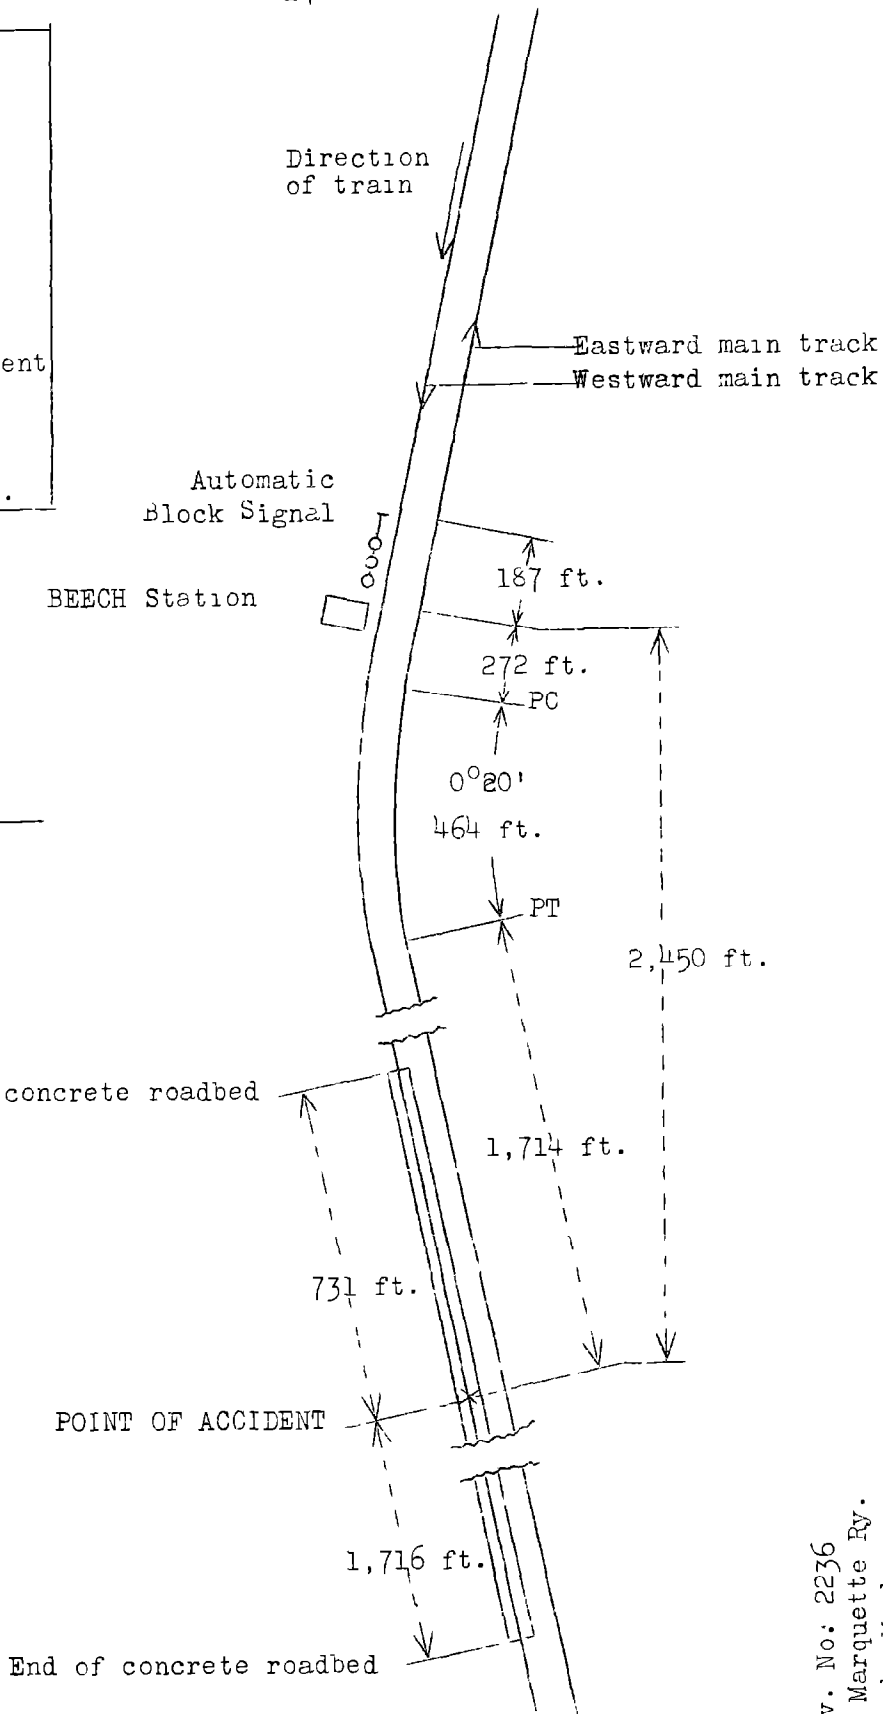
Inv. No: 2236
 Pere Marquette Ry.
 Beech, Mich.
 Dec. 17, 1937

For a distance of 1,716 feet westward, beginning at a point 1,719 feet west of Beech station, the track is laid on a concrete slab roadbed. Of this stretch, 1,326 feet on the east end was laid in 1926 while the balance was laid in 1929. The derailment occurred on the older stretch of this roadbed; the track structure consists of steel-reinforced concrete slabs 39 feet long, 10 feet wide and 21 inches thick. The steel reinforcement consists of a structural frame made up of two longitudinal trusses placed vertically in the plane of the two rails and secured by $\frac{3}{4}$ -inch tie-rods spaced at intervals of 6 feet along the top chord of the truss, and steel-bar cross-frames spaced 12 feet apart. At intervals of 27 inches $\frac{1}{2}$ by 2-inch steel stirrups are bolted to the top chord; these stirrups are designed to provide means for bolting rail-clips to each side of the rail for the purpose of securing the rail to the roadbed. These rail-clips are 2 by $3\frac{1}{4}$ by $\frac{3}{4}$ inches and the bottom face of each is chamfered along the edge in such manner as to fit the rail base. The track bolts used to secure the rail-clips to the stirrups are $2\frac{1}{2}$ by $\frac{3}{4}$ inches. In order to provide insulation for the rails, a fibre plate $\frac{1}{8}$ inch thick by $5\frac{1}{4}$ inches wide is placed beneath the base of the rail

The evidence indicates that no defect existed in the equipment of No. 103 that would have caused the derailment; there was no indication that anything had been dragging. There were indications, however, that wide gauge resulting from spreading of the track had developed. Four feet 9 inches is the normal gauge on this concrete roadbed. After the accident the gauge of the track east of the point of derailment ranged from 4 feet 9 inches to 4 feet 10 $\frac{1}{2}$ inches; west of the point of derailment the rail was pushed away from its fastenings and 261 fastenings on the north side of the north rail were broken off. The evidence disclosed that since the concrete roadbed was placed in service breakage of track anchor bolts has been frequent and a daily patrol has been found necessary to insure safe maintenance. In the 16 days in December prior to the date of the accident, 15 bolts were replaced and about 10 of these replacements were made on December 14th. The insulation used under the rail and under the rail clips in this installation is subject to swelling when water-soaked, and the division engineer advanced the theory that due to a rain which fell 2 days prior to the accident saturation took place and the freezing temperature which followed the rain caused swelling of the insulation sufficient to raise the clips and permit the base of the rail to move outward under the pressure of the weight of a train. The division engineer also stated that the manner in which the rail was bent around the last anchor bolt which remained in place suggested that a powerful blow of some kind delivered near that point had initiated the outward movement of that rail, but nothing to substantiate this theory was found. Two days before the accident the anchor bolts were inspected and none was found to be loose; this was the last inspection made of the track on the concrete roadbed prior to the accident except observations made while moving over it on a motor car.
