REPORT OF THE DIRECTOR  
BUREAU OF SAFETY

ACCIDENT ON THE  
DULUTH, SOUTH SHORE AND ATLANTIC RAILWAY

MICHIGAMME, MICH.

INVESTIGATION NO. 2341

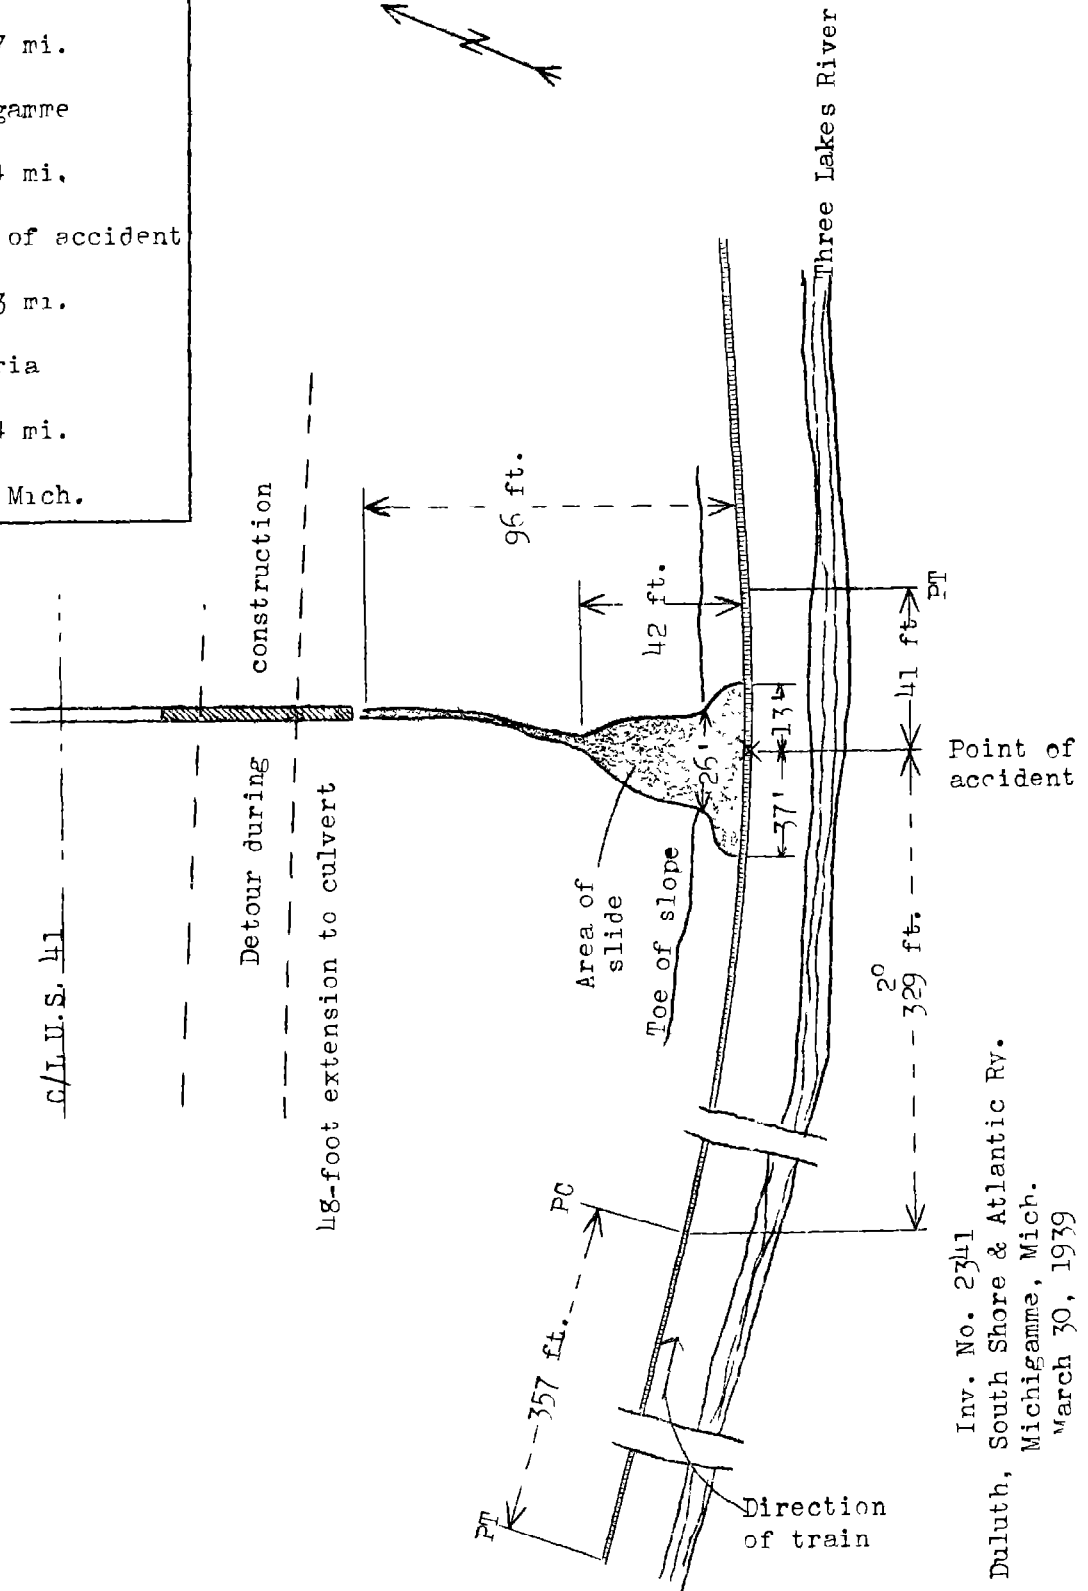
Inv. No. 2341  
 Duluth, South Shore & Atlantic Ry.  
 Michigan, Mich.  
 March 30, 1939

o	East Yard, Mich.
	38.7 mi.
o	Michigan
	3.4 mi.
X	Point of accident
	4.3 mi.
o	Nestoria
	54.4 mi.
o	Ewen, Mich.

In the immediate vicinity of the point of derailment the track is laid through a hill-side cut about 150 feet in length. To the north side of the track a slope, the toe of which is 5 feet from the center-line, rises to a height of 44 feet at a point 110 feet from the track, or at a ratio of 2 to 5. The formation is composed of a mixture of rock, clay, sand, and gravel, the surface of which is covered with grass and brush. U. S. Highway No. 41 is located at the top of the slope and parallels the track, its center-line being 175 feet north of the center-line of the track. A detour road had been built by a construction company between the rim of the slope and U. S. Highway No. 41 for use during the reconstruction of the latter road. Before the detour road was built an 18-inch culvert under the highway provided drainage from a hill and a marshy basin on the north to a ditch paralleling the highway on the south side. A 48-foot extension to this culvert was installed under the detour road, resulting in its outlet being located about 96 feet from the center-line of the track and causing the drainage to be diverted to the slope toward the track and Three Lakes River which is located to the south of the track. The north bank of the river is from 10 to 50 feet from the roadbed.
