REPORT NO. 3487
DULUTH, SOUTH SHORE & ATLANTIC
RAILROAD COMPANY
IN RE ACCIDENT
NEAR ONOTA, MICH., ON
OCTOBER 3, 1952

REPORT NO. 3487

Accident near Onota, Mich., on October 3, 1952, caused
by failure to provide adequate protection for the
movement of a track motor-car.

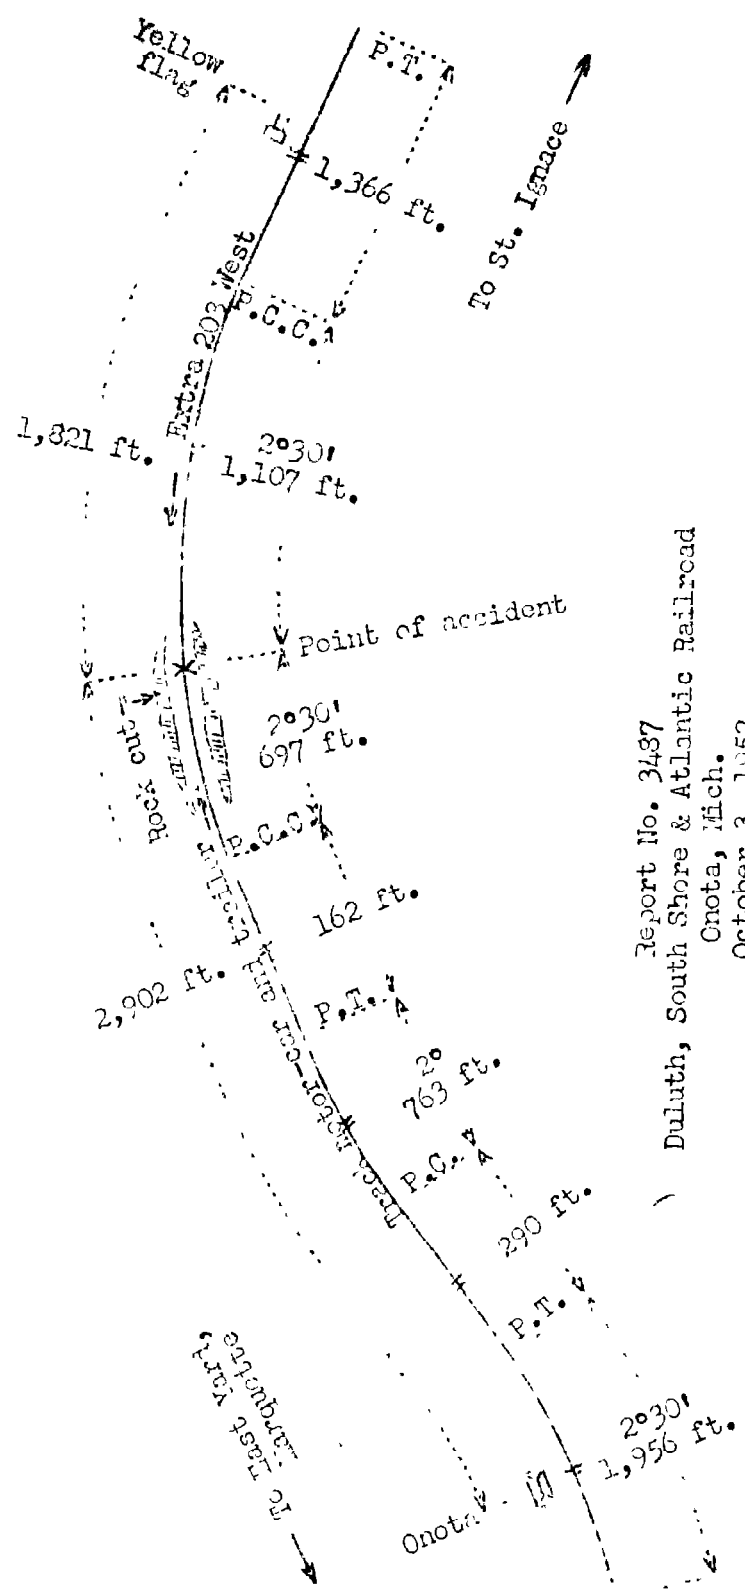
Report No. 3487
 Duluth, South Shore & Atlantic Railroad
 Onota, Mich.
 October 3, 1952

Location of Accident and Method of Operation
