REPORT NO. 3354  
THE PENNSYLVANIA RAILROAD COMPANY  
IN RE ACCIDENT  
NEAR BOYNE FALLS, MICH., ON  
AUGUST 26, 1950

Kind of accident: Head-end collision

Accident near Boyne Falls, Mich., on August 26, 1950,  
caused by an inferior train occupying the main  
track on the time of an opposing superior train  
without protection.

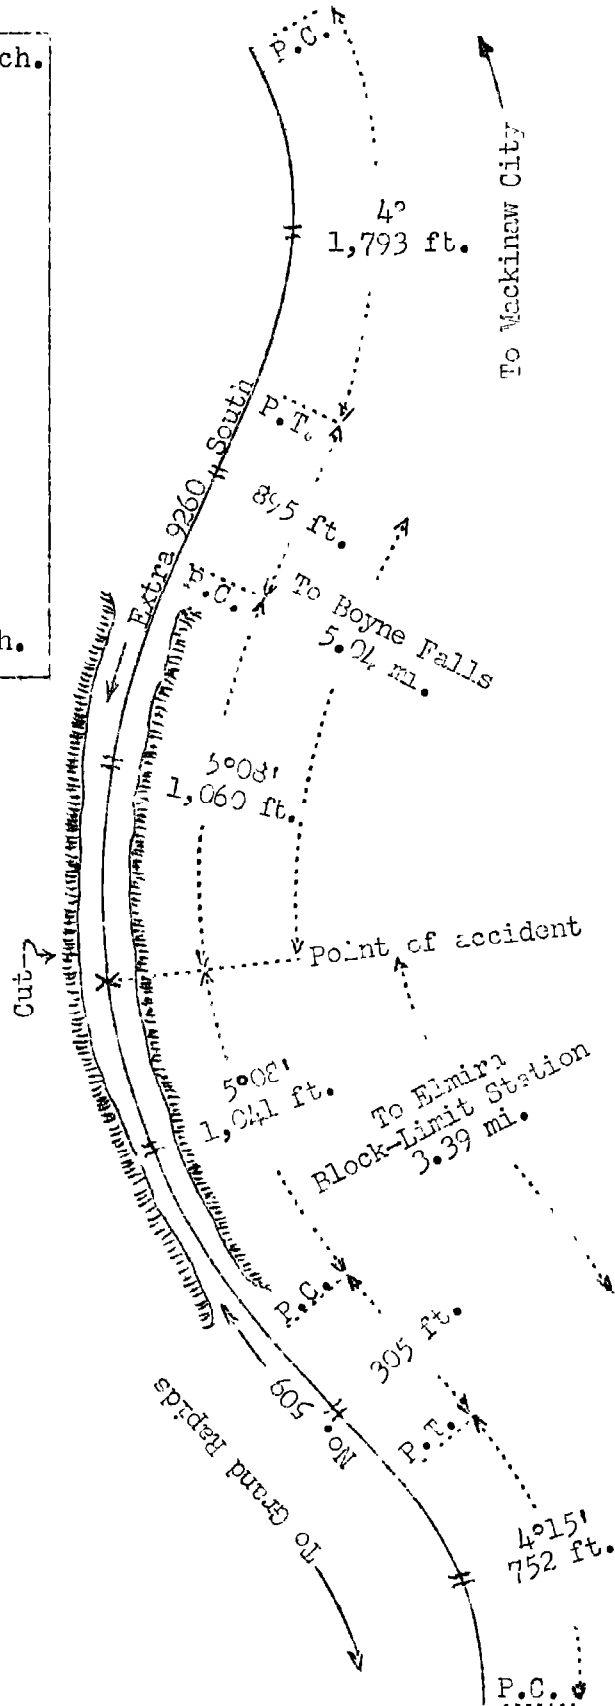
Report No. 3354  
 Pennsylvania Railroad  
 Boyne Falls, Mich.  
 August 26, 1950

o	Mackinaw City, Mich.	34.90 mi.
o	Petoskey	1.80 mi.
o	Formans	14.00 mi.
o	Boyne Falls	5.04 mi.
X	Point of accident	3.86 mi.
o	Elmira	15.20 mi.
o	Mancelona	21.50 mi.
o	South Boardman	31.60 mi.
o	Cadillac	97.80 mi.
o	Grand Rapids, Mich.

Location of Accident and Method of Operation
