REPORT NO. 3470
GRAND TRUNK WESTERN RAILROAD COMPANY
IN RE ACCIDENT
NEAR LINDEN, MICH., ON
JUNE 29, 1952

Kind of accident: Head-end collision

Accident near Linden, Mich., on June 29, 1952, caused by
failure to obey a meet order.

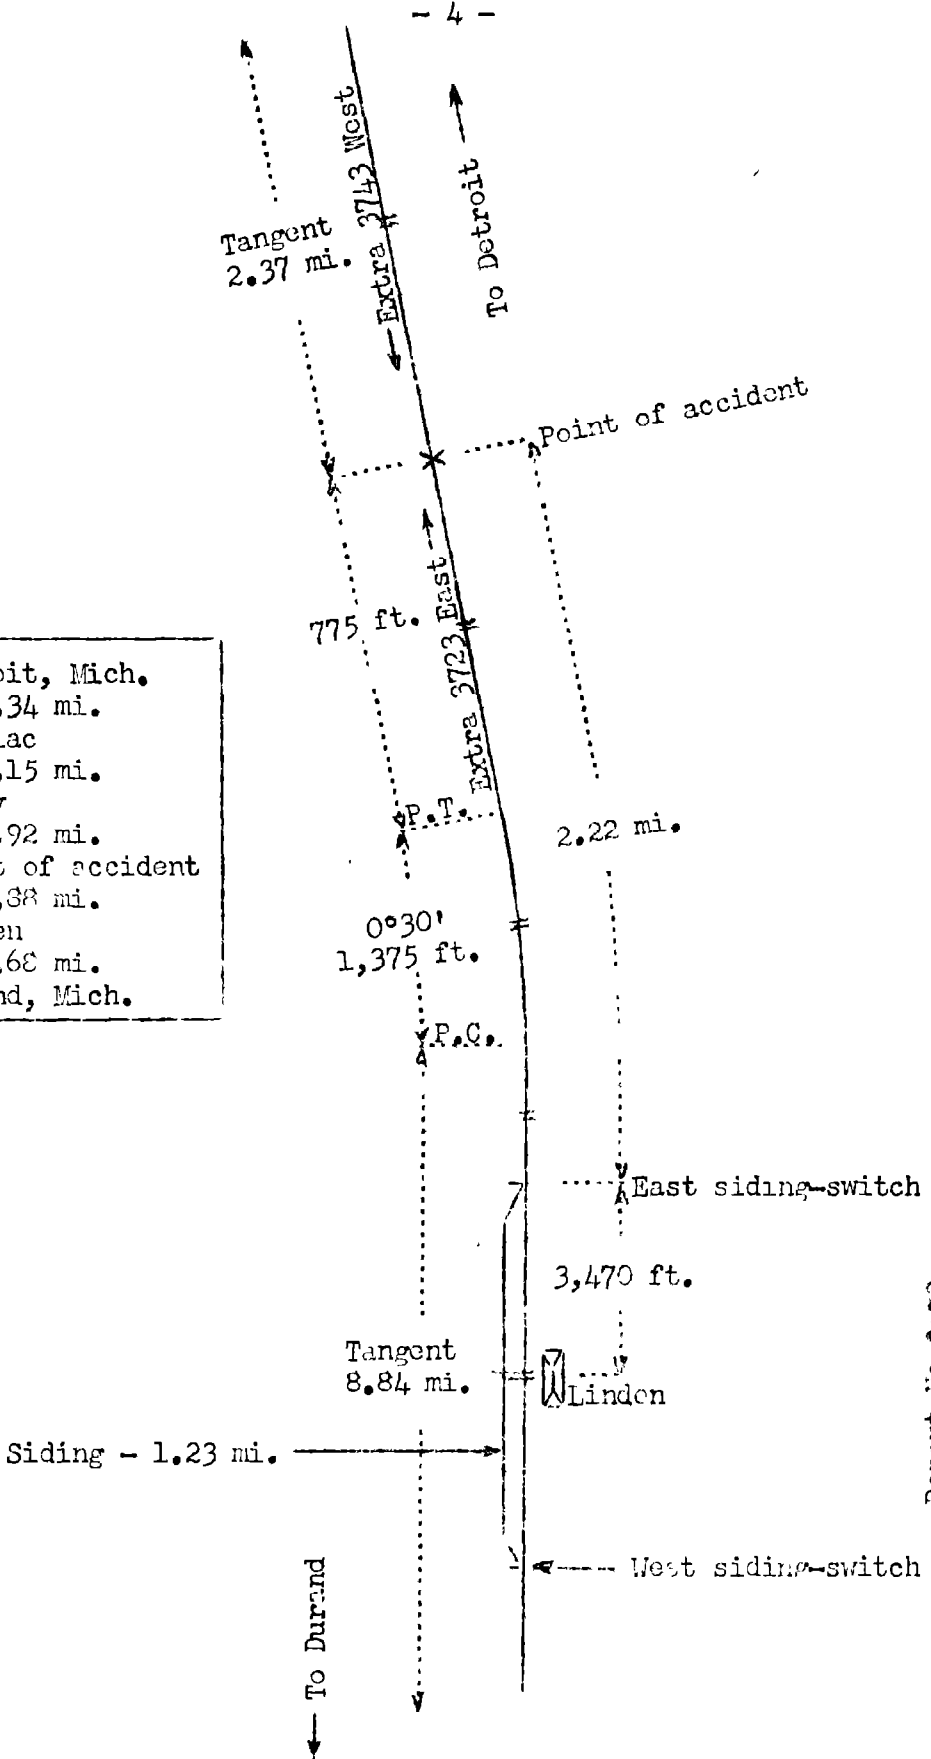
Report No. 3470
 Grand Trunk Western Railroad
 Linden, Mich.
 June 29, 1952

o	Detroit, Mich.
	26.34 mi.
o	Pontiac
	20.15 mi.
o	Holly
	5.92 mi.
X	Point of accident
	2.38 mi.
o	Linden
	11.68 mi.
o	Durand, Mich.
